Application Note 89: Flour Analysis – Starch Damage and Water Absorption

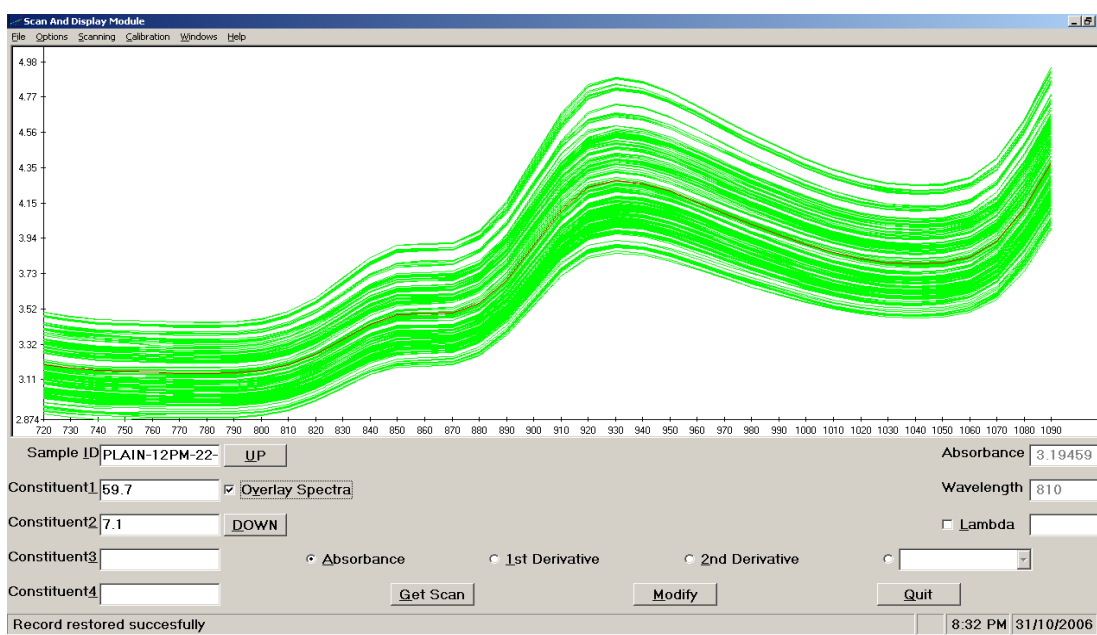
Figure 1. NIT Spectra of Flour

29 samples of Australia flour were collected and analysed using the Brabender Farinograph to determine the Starch Damage and Water Absorption. The samples were then scanned using a Cropsan 2000F Flour Analyser across the spectral range, 720-1100nm. A 5mm pathlength Powder Cell was used to present the flour samples to the Cropsan 2000F which uses a Moving Sample Transport to scan up to 10 portions of each sample. Each sample was scanned in duplicate and the 20 scans were saved in the Cropsan 2000F's memory chip and later uploaded to a PC using NTAS(NIR Technology Analysis Software). Figure 1. shows the NIT spectra for the 29 samples of flour.

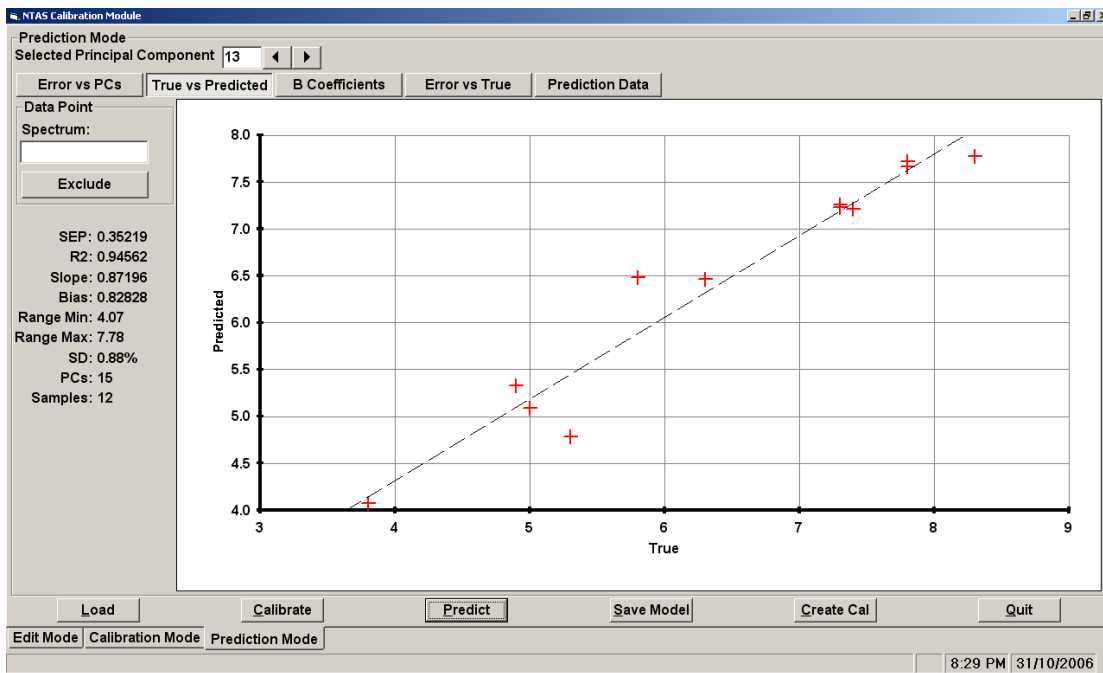
Figure 2. Calibration Plot for NIR Starch Damage vs Farinograph Starch Damage

Figures 2 and 3. show the plot of the NIT calibration data vs the Farinograph data.

In Application Note 47, showed the Standard Error of Calibration (SEC) to be 0.06 for Starch Damage and 0.55 for Water Absorption. In this study the SEC were determined to be 0.36 for Starch Damage and 0.46 for Water Absorption.

In the previous study, the range for Starch Damage was 9.0 to 13.0, where as the range for this study was 3.8 to 8.2. The ranges for Water Absorption were approximately the same, ie, 54 to 65. The much higher SEC for Starch Damage for this study cannot be explained.

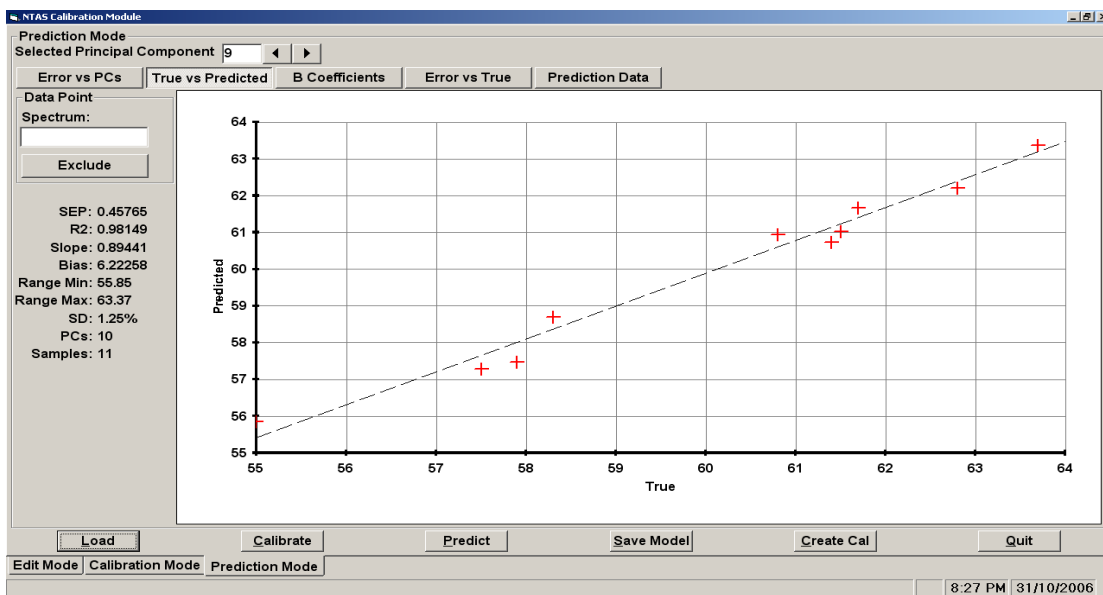
Figure 3. Calibration Plot for NIR Water Absorption vs Farinograph Water Absorption
